De Gull Wing

November/February 1987
Volume 5 Number 3 & 4

OFFICIAL PUBLICATION FOR OVER 3000 MEMBERS OF THE DELOREAN MOTOR CLUB OF AMERICA, INC.

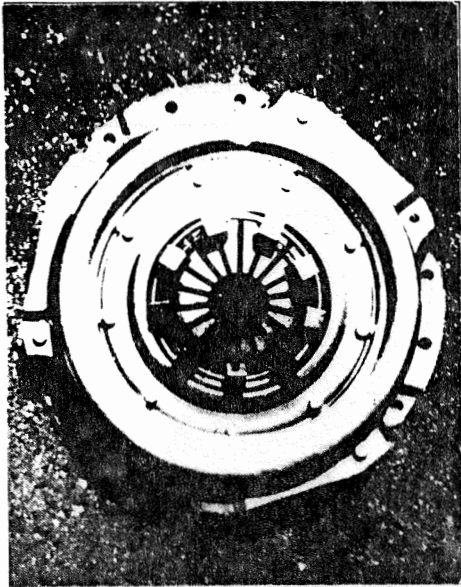
HEAVY DUTY CLUTCH

This heavy duty diaphragm clutch is totally unique because it has light, comfortable pedal pressure without sacrificing the high performance characteristics needed in freeway and recreational driving.

How this clutch system works is that it uses a specifically engineered system of weights attached to the diaphragm spring. This keeps the diaphragm from sticking "over center" at higher RPM shifts (tested to 12,000 RPM), interlocks the diaphragm spring fingers together, creating a more positive, faster engagement and increases "clamp load" pressure as the engine RPM increases.
